## ALERT OPERATORS TRANSMISSION - AOT

SUBJECT: ATA 32 – Main Landing Gear Door Actuator quality issue during manufacturing

AIRCRAFT TYPE: A318, A319, A320, A321

OUR REF.: A32N033-24 Rev 02 dated 27-JUN-2025

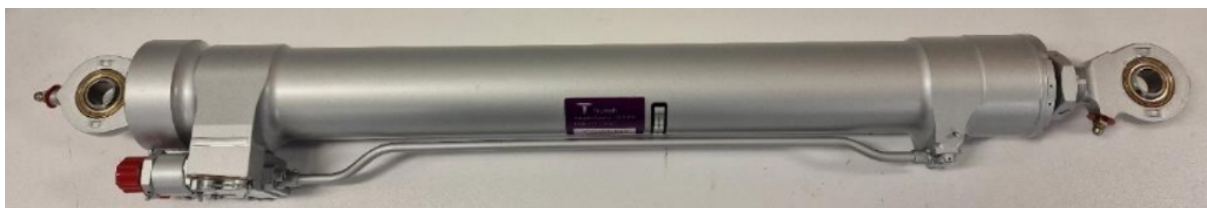
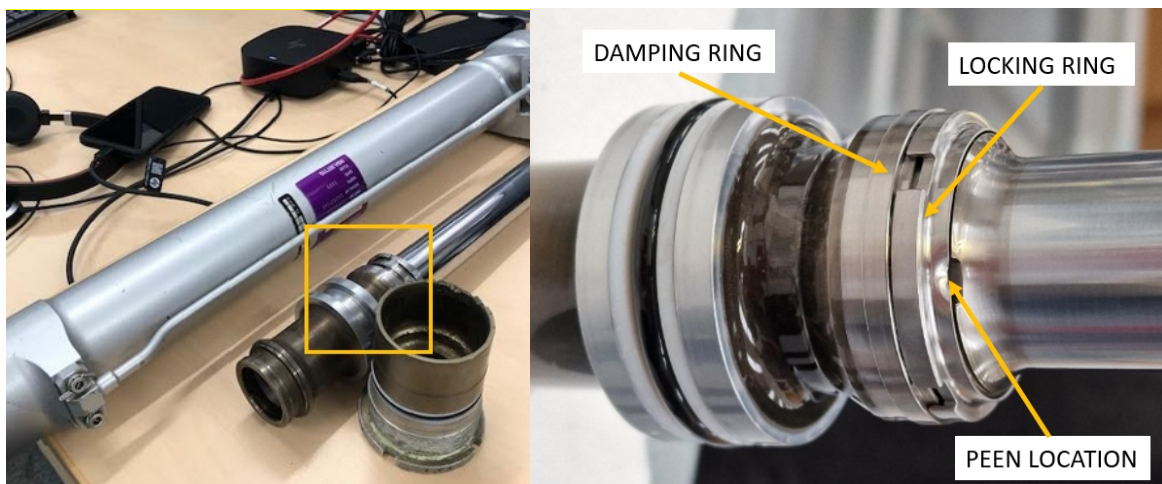
The MLG Door Actuator includes a damping device at the end of the stroke that provides progressive damping during extension. This damping device is composed of a damping ring (item 2-140 of CMM 32-31-35) held in place by a threaded locking ring (item 2-135 of CMM 32-31-35). In addition to the torque, this locking ring is locked in place by a deforming (peening) process on the piston rod.

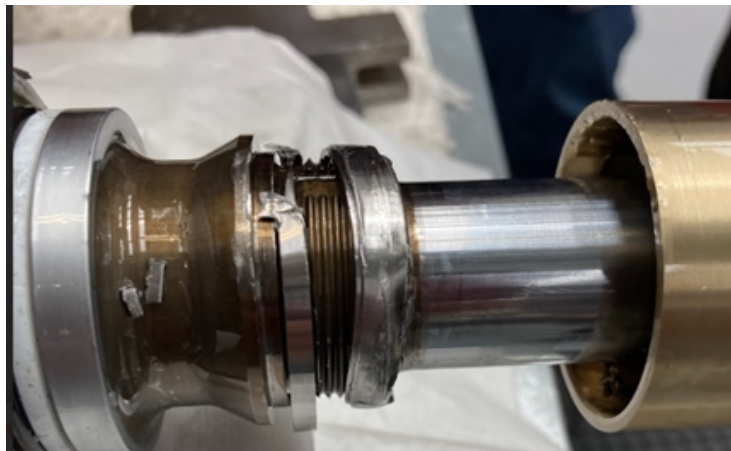
The shop inspection of the failed MLG Door Actuators P/N 114122015 showed the threaded locking ring unscrewed and the piston damping ring and adjacent part damaged (see example of the damage on the following picture).

As a result of the locking ring being unscrewed, the damping ring and the adjacent part became detached and damaged during actuator operation.

Laboratory investigation of the failed MLG Door Actuators P/N 114122015 showed that the threaded locking ring had not been deformed (not peened) as required by the assembly process (reference 1 - paragraph Assembly - 2. Procedure - C.8.h).

An in-depth quality investigation performed by AIRBUS and the Original Equipment Manufacturer (TRIUMPH) has determined that the piston assembly was not assembled correctly.

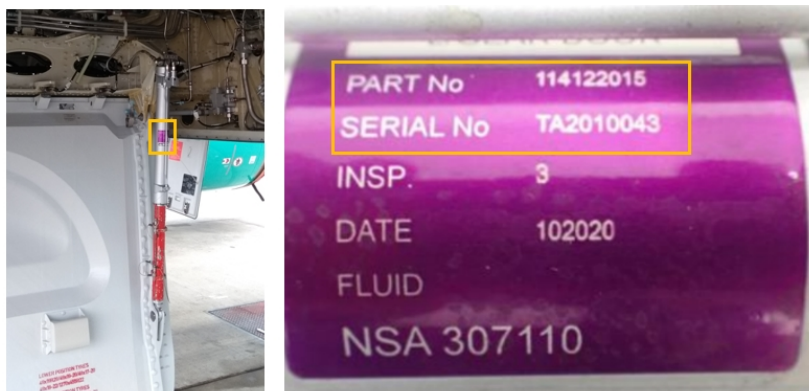
B) As an alternative to the landing gear records check, the P/N and the S/N can be checked physically on the nameplate (CMM 32-31-35 item 2-240) localized on the cylinder middle area (see following picture).

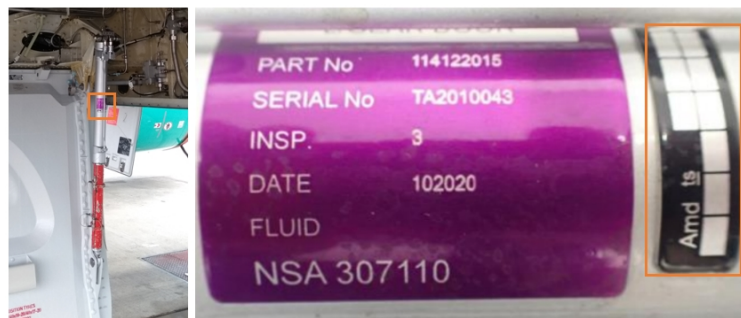
3/ Check physically if the amendment plate (CMM 32-31-35 item 2-220) of the MLG Door Actuator listed in the appendix 1 lists has the reference "PINSP" scribed (see pictures below).

NOTE: Any actuator listed in Appendix 1 lists with the ref "PINSP" scribed on the Amendment plate, is no longer considered suspected. No actions are required for actuators listed in appendix 1 lists with reference "PINSP" scribed on the amendment plate.

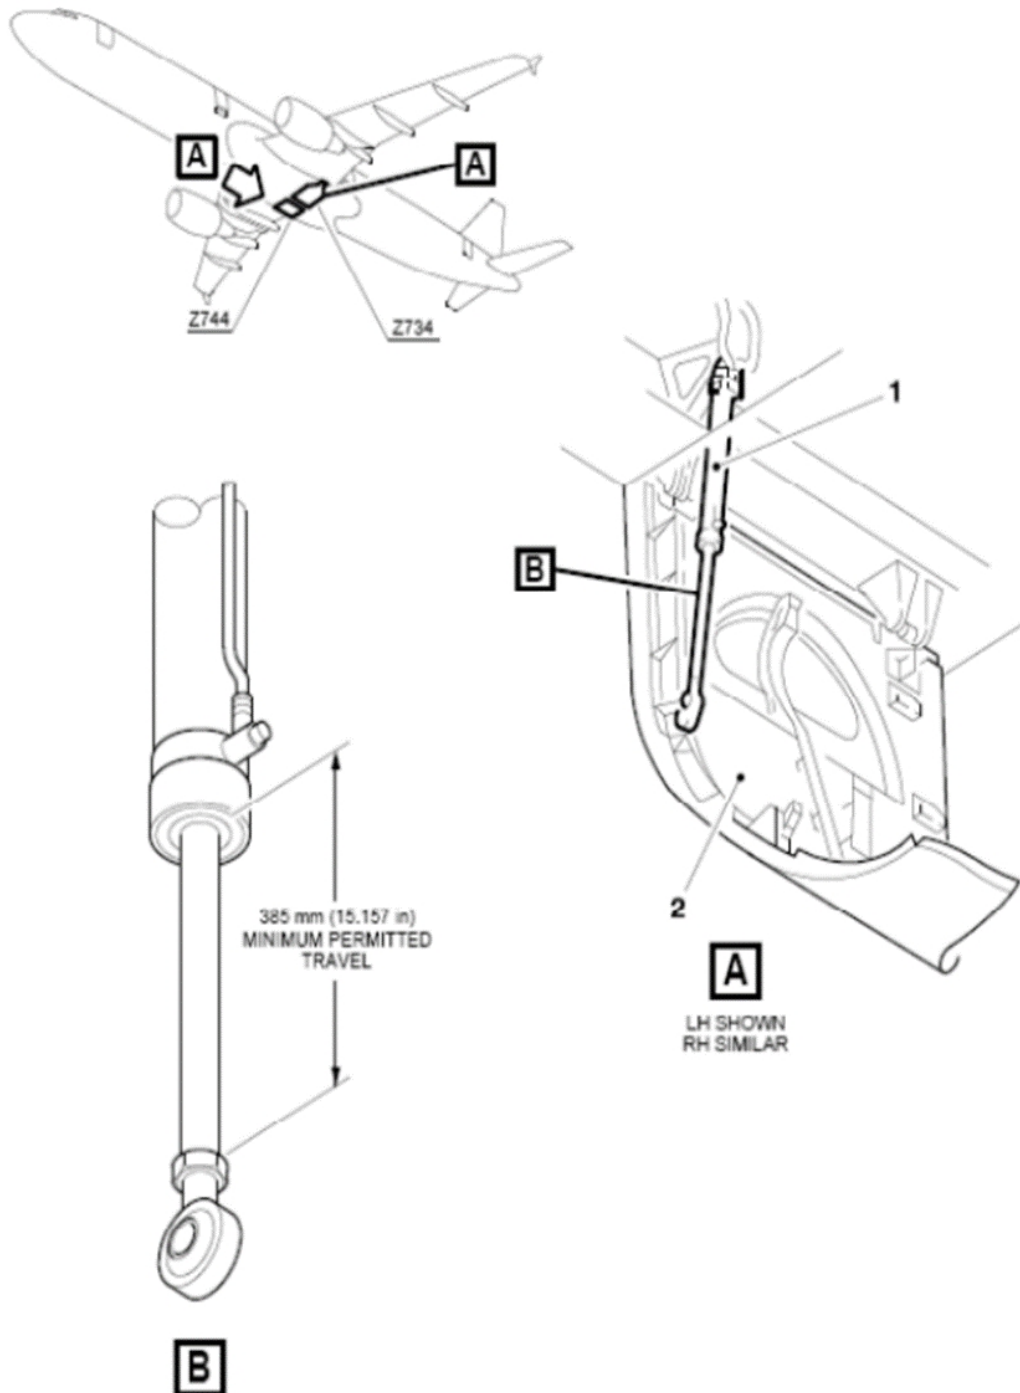
### APPENDIX 2 - MLG Door Actuator inspection measurement

| ACTION | RESULT |
|---|---|
| 4.Measure the dimension (DIM A) with the MLG door fully opened (appendix 2). | -The dimension (DIM A) must not be less than 385 mm (15.157 in.). |

5. If the MLG Door Actuator fails any of the above 4 inspections checks, it must be replaced before next flight in accordance with repair procedure of paragraph 5.6.4.

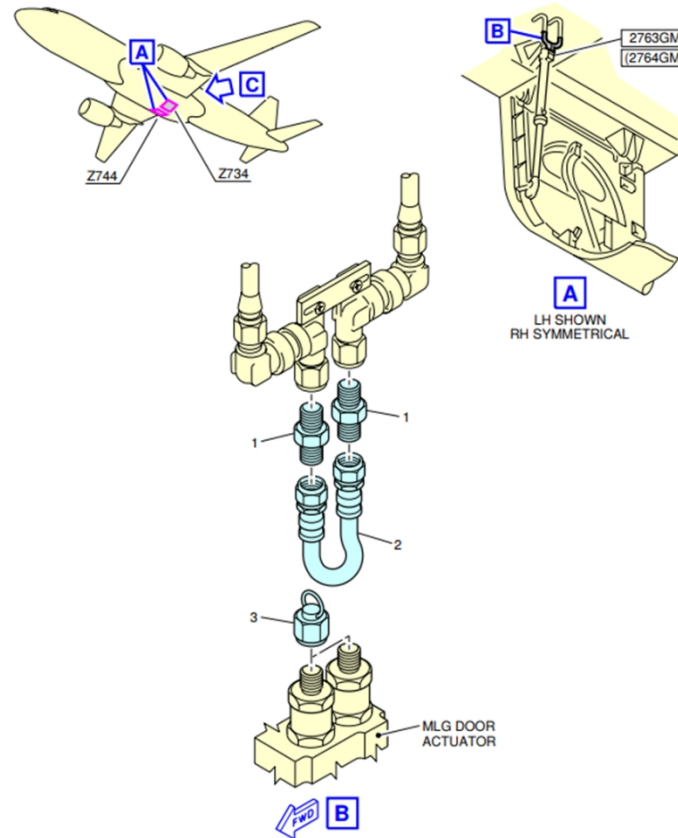
Illustration 3 - Flushing of the MLG Door Actuator Pipelines

NOTE: Flushing is required as debris resulting from the internal damping mechanism components damage may contaminate the MLG Door Actuator hydraulic lines.

Appendix 4 provides the required procedure to flush the potential contamination from the hydraulic landing gear extension and retraction lines in addition to the replacement of the MLG Door Actuator.
