ALERT OPERATORS TRANSMISSION - AOT

SUBJECT: ATA 32 – Main Landing Gear Door Actuator quality issue during manufacturing

AIRCRAFT TYPE: A318, A319, A320, A321

OUR REF.: A32N033-24 Rev 03 dated 25-MAR-2026

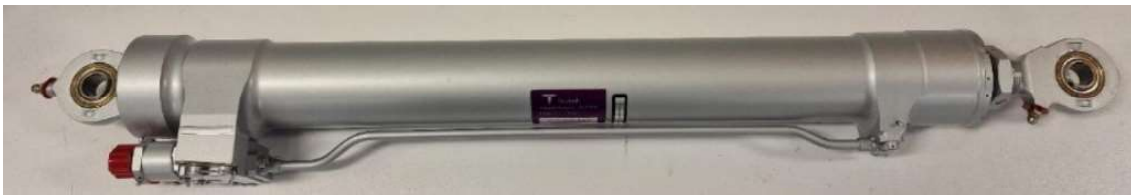
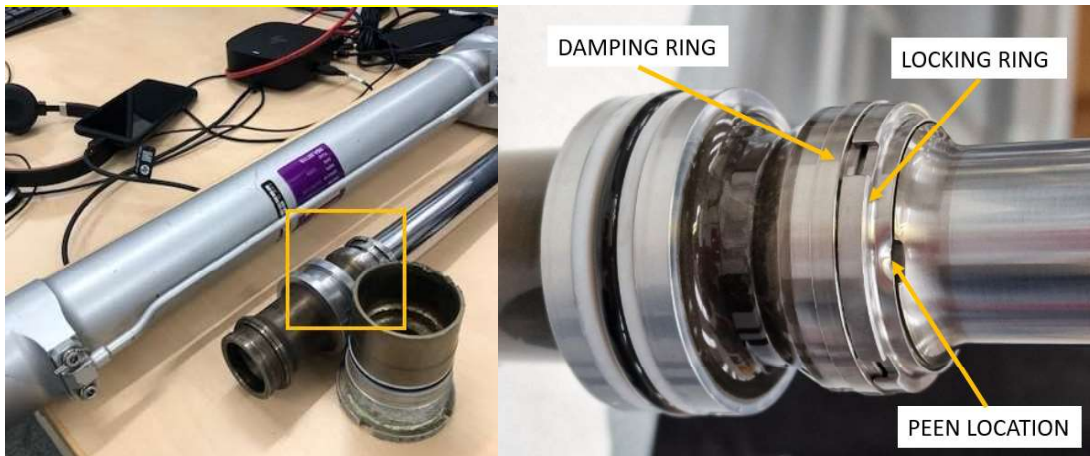
The MLG Door Actuator includes a damping device at the end of the stroke that provides progressive damping during extension. This damping device is composed of a damping ring (item 2-140 of CMM 32-31-35) held in place by a threaded locking ring (item 2-135 of CMM 32-31-35). In addition to the torque, this locking ring is locked in place by a deforming (peening) process on the piston rod.

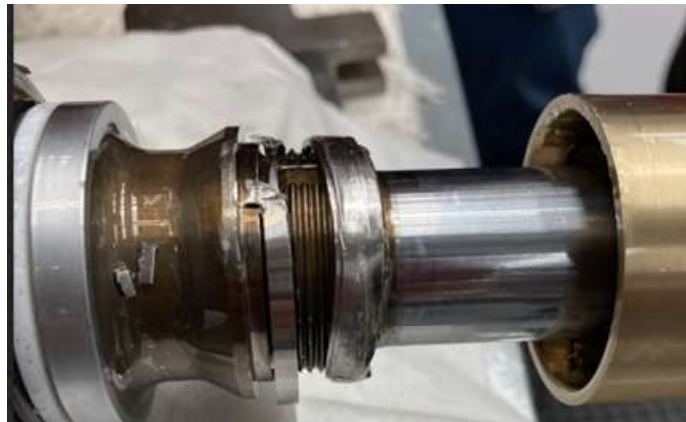
The shop inspection of the failed MLG Door Actuators P/N 114122015 showed the threaded locking ring unscrewed and the piston damping ring and adjacent part damaged (see example of the damage on the following picture).

As a result of the locking ring being unscrewed, the damping ring and the adjacent part became detached and damaged during actuator operation.

Laboratory investigation of the failed MLG Door Actuators P/N 114122015 showed that the threaded locking ring had not been deformed (not peened) as required by the assembly process (reference 1 - paragraph Assembly - 2. Procedure - C.8.h).

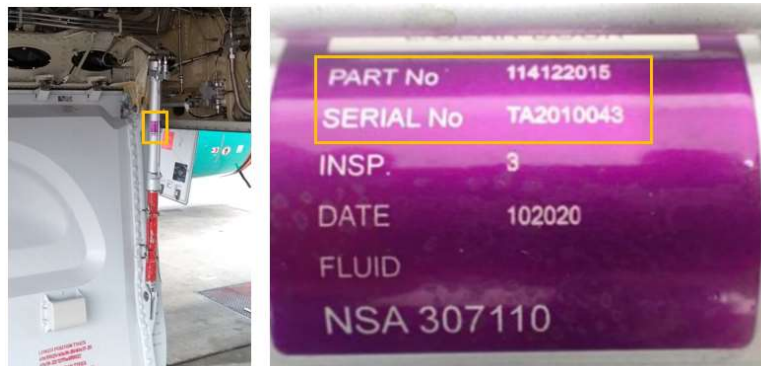
B) As an alternative to the landing gear records check, the P/N and the S/N can be checked physically on the nameplate (CMM 32-31-35 item 2-240) localized on the cylinder middle area (see following picture).

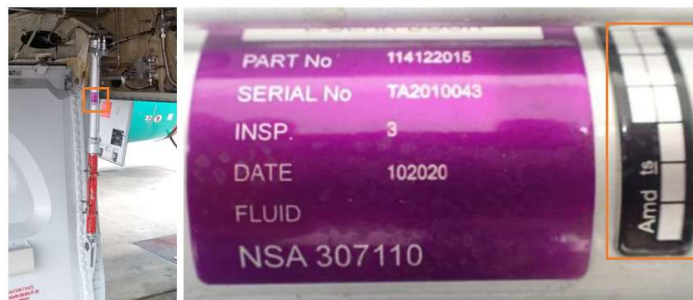
3/ Check physically if the amendment plate (CMM 32-31-35 item 2-220) of the MLG Door Actuator listed in the appendix 1 lists has the reference "PINSP" scribed (see pictures below).

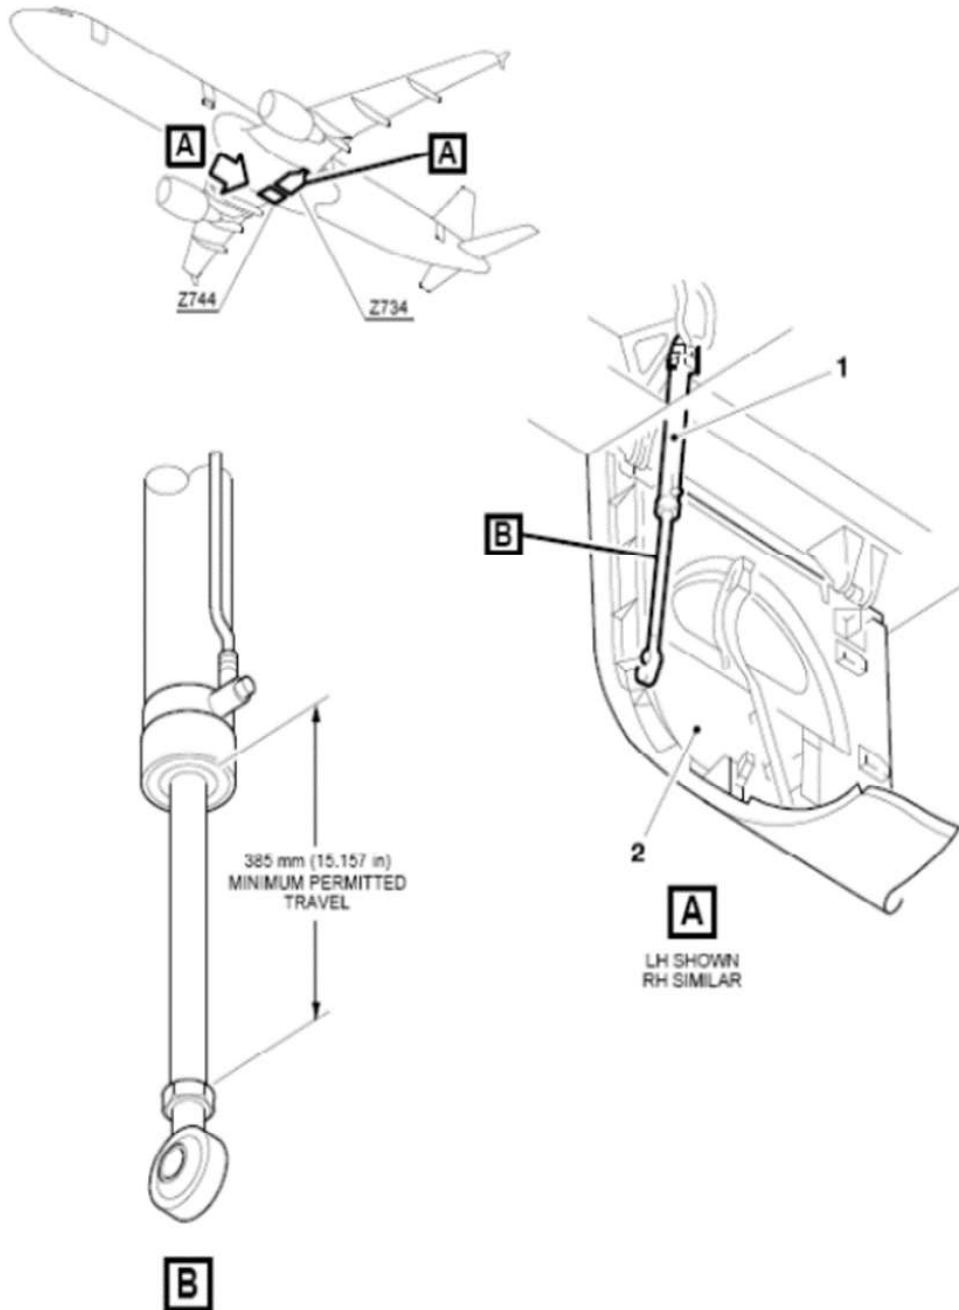
APPENDIX 2 - MLG Door Actuator inspection measurement

ACTION	RESULT
1. Move the applicable ground door-operating handle to the OPEN position Ref. AMM TASK 32-12-00-010-001. Wait for 30 seconds.	-The related MLG door moves to the fully open position -The applicable MLG door actuating-cylinder is vertical.
2. Make sure that the movement of the MLG door actuating-cylinder is smooth and continuous.	-The movement of the MLG Door Actuating cylinder is smooth and continuous.
3. Move the MLG door with your hand through approximately 30 degrees and back to the fully open position.	-The movement of the MLG door actuating-cylinder must be smooth and continuous. There must be hydraulic resistance only.
4. Measure the dimension (DIM A) with the MLG door fully opened (appendix 2).	-The dimension (DIM A) must not be less than 385 mm (15.157 in.).

5. If the MLG Door Actuator fails any of the above 4 inspections checks, it must be replaced before next flight in accordance with repair procedure of paragraph 5.6.4.

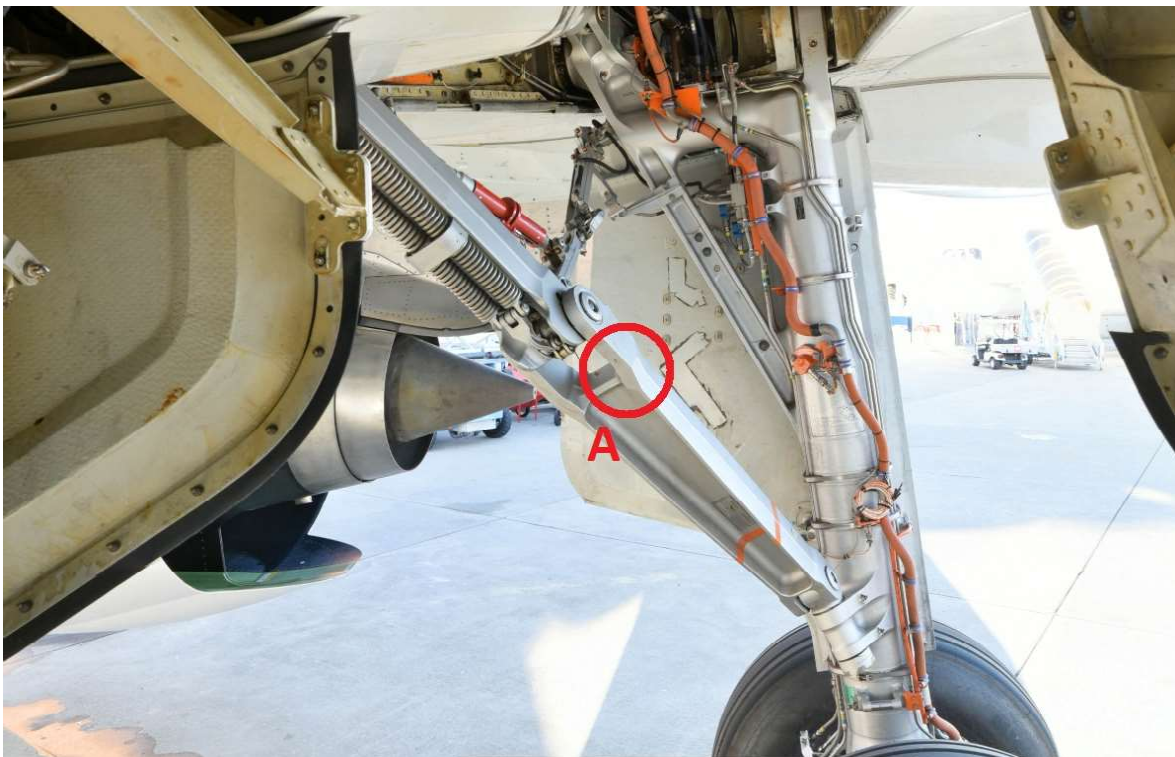
- 2) Attach the RATCHET STRAP (No Specific) to the Side stay and MLG-door uplock roller:
 - a. Ensure the RATCHET STRAP is in functioning condition.
 - b. Place a CLOTH around the lower Side stay (A).
 - c. Secure the RATCHET STRAP from MLG-door uplock roller to the lower Side stay (A).

NOTE: Avoid attaching the RATCHET STRAP to any forms of ancillaries or joints.
